REPORT ON TAPI BAORI

Architectural Documentation on Tapi Baori of Jodhpur

School of Architecture & Design

September 05, 2022

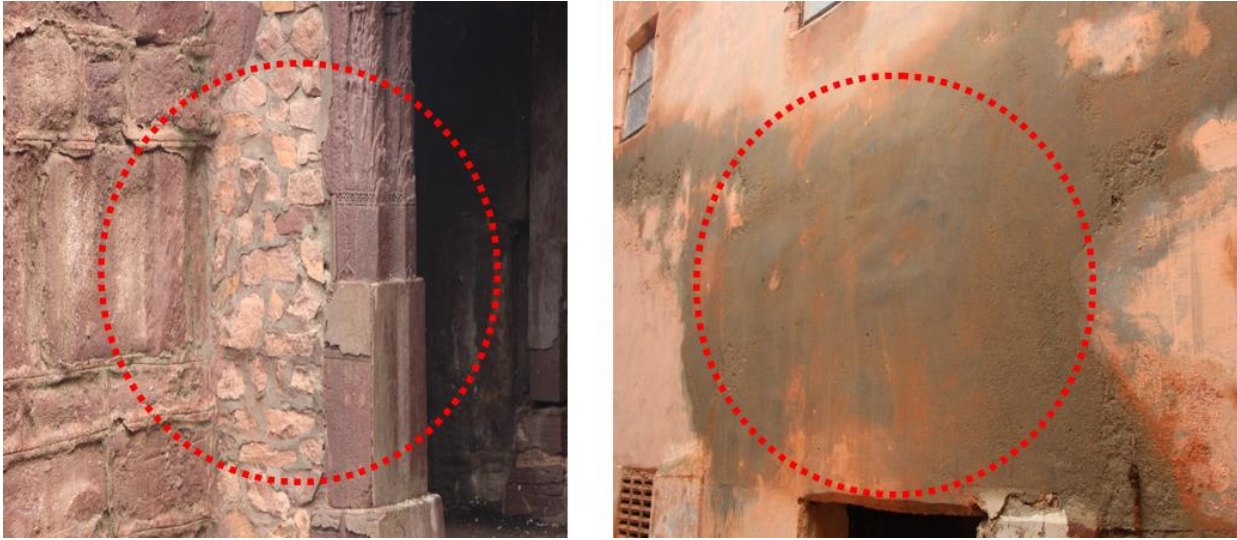
- (a) **Alterations**: - Modification of the material does not necessarily a worsening of its characteristics from the point of view of conservation. For instance, a reversible coating applied on a stone may be considered an alteration.

- Factors unforeseeable at the early stage
- Total or partial change of use
- Change of ownership necessitating enlargement, extension, or other changes.
- Failure of building components
- Changing technological possibilities.
- Restoration of old monuments
- Wear and tear

Figure 9: Restoration of old monuments

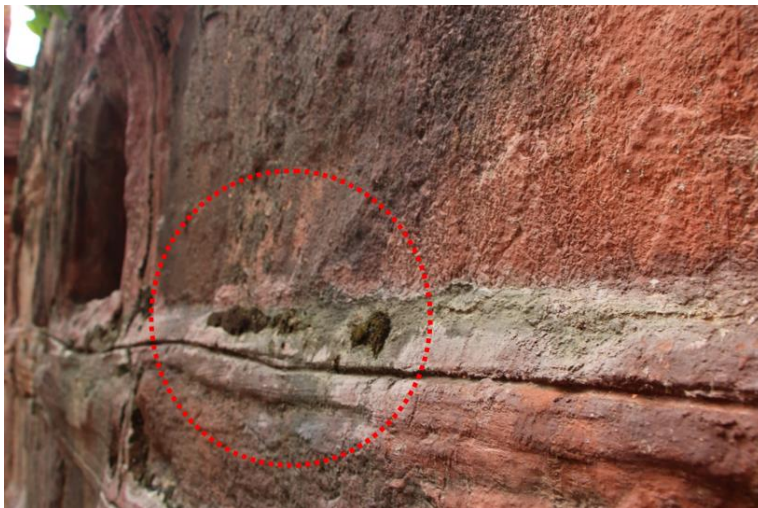
(b) Alveolisation: - Formation, on the stone surface, of cavities (alveoles) which may be interconnected and may have variable shapes and sizes (generally centimetric, sometimes metric). Alveolization is a kind of is a differential weathering possibly due to inhomogeneities in physical or chemical properties of the stone.

- Change in physical and chemical properties of stone
- Loosing of masonry
- Human intervention
- Biological habitation

Figure 10: Change in physical and chemical properties of stone

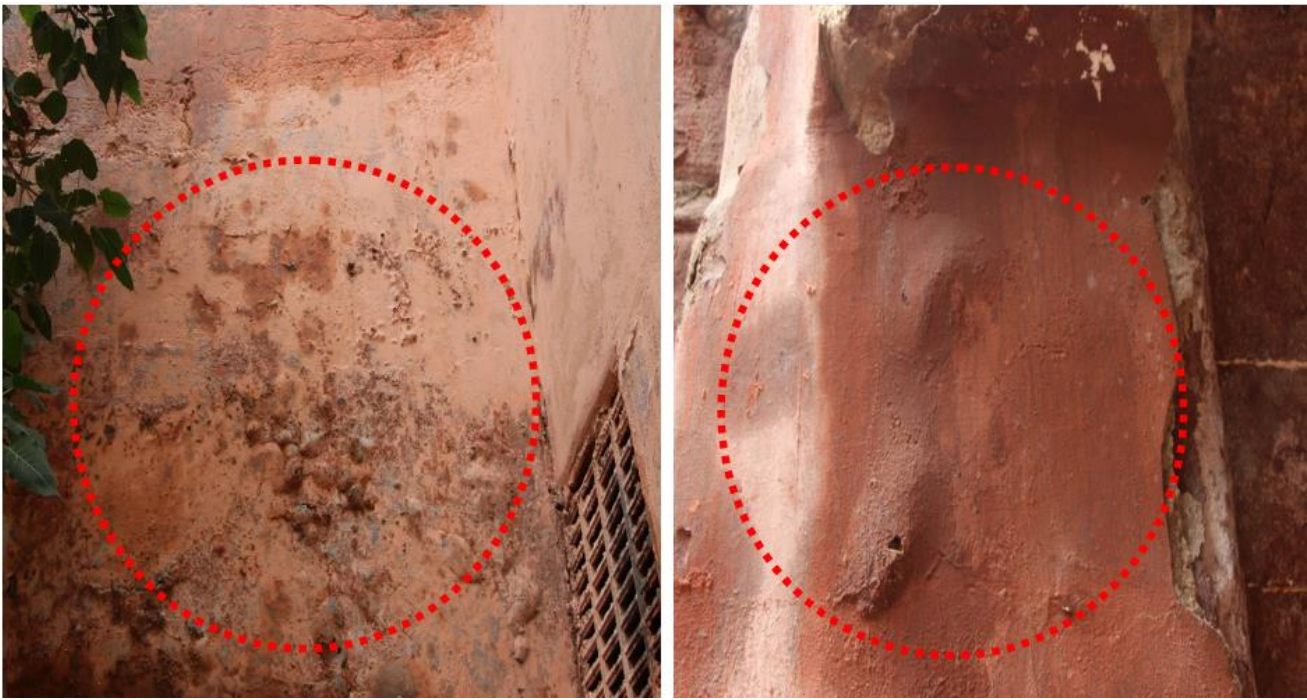
(d) Blistering: - Separated, air-filled, raised hemispherical elevations on the face of stone resulting from the detachment of an outer stone layer. This detachment is not related to the stone structure.

- Moisture change
- Elastic deformation
- Change in temperature
- Corrosion of reinforcement
- Vegetation growth

Figure 11: Elastic deformation

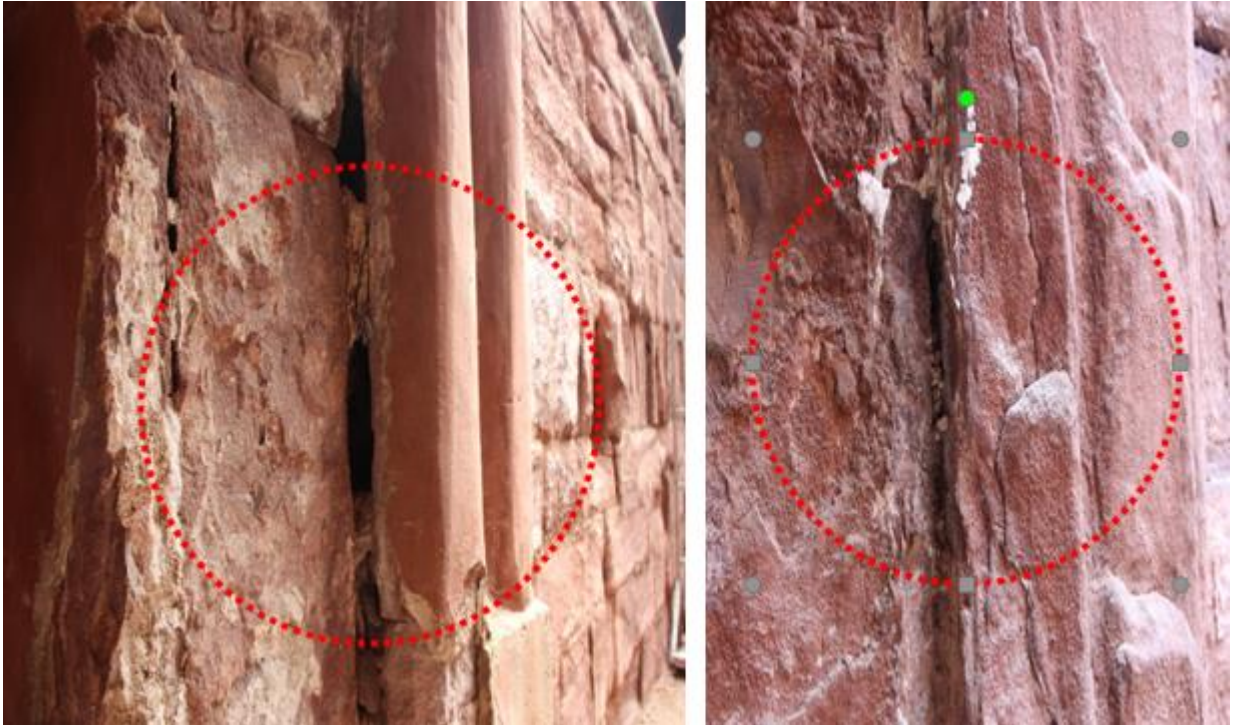
(e) Cracks: - Individual fissures, clearly visible by the naked eye, result from the separation of one part from another. - Fracture: Crack that crosses completely the stone piece - Star cack: Crack having the form of a star. Rusting iron or mechanical impact are possible causes of this type of damage. - Hair crack : Minor crack with width dimension < 0.1 mm

- Exposure of surface
- Natural wear and tear

Figure 12: Natural wear and tear

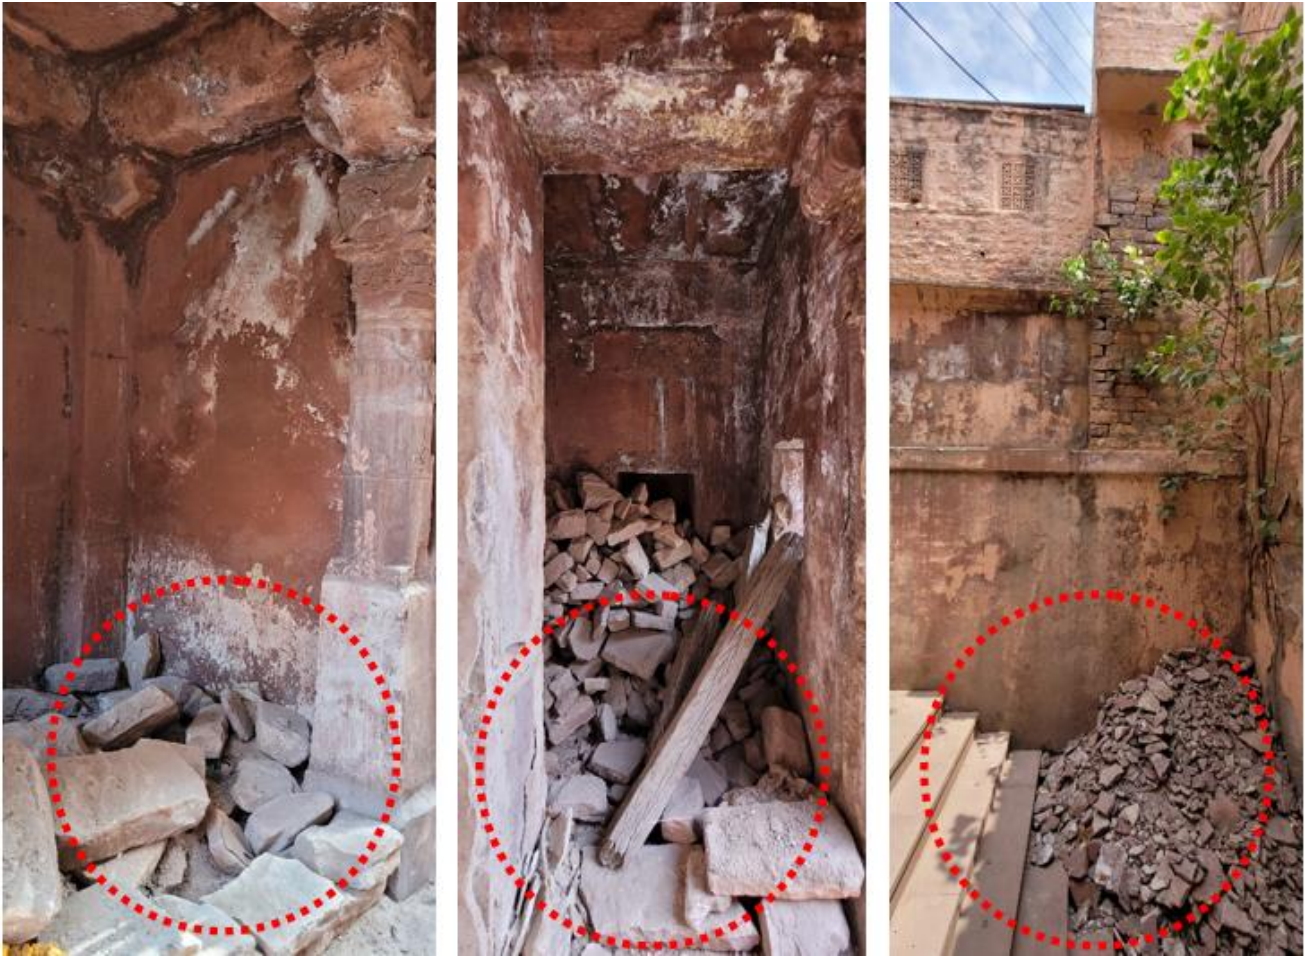
(f) Debris: - Scattered pieces of rubbish or remains. It also includes loose natural material consisting especially of broken pieces of rock.

- Demolition
- Chipping
- Lack of maintenance
- Accumulation of chipped material

Figure 17: Debris

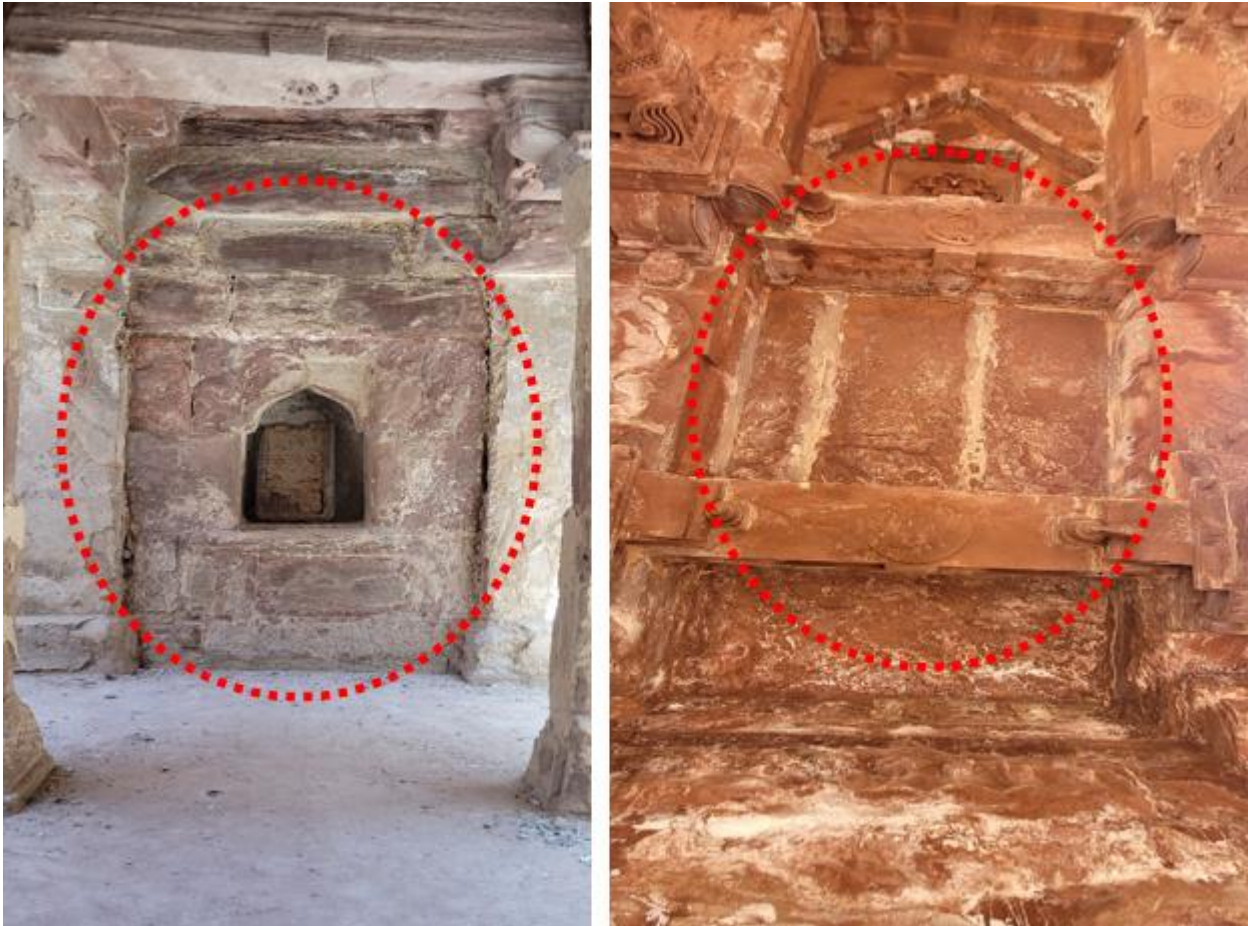
(g) Delamination: - Detachment process affecting laminated stones (most of the sedimentary rocks, some metamorphic rocks). It corresponds to a physical separation into one or several layers following the stone laminae. The thickness and shape of the layers is variable. The layers may be oriented in any direction regarding the stone surface.

- Weathering
- Incorrect orientation of stones
- Natural phenomena
- Exposure of material for long periods

Figure 18: Different layers of stone is visible due to exposure to weathering

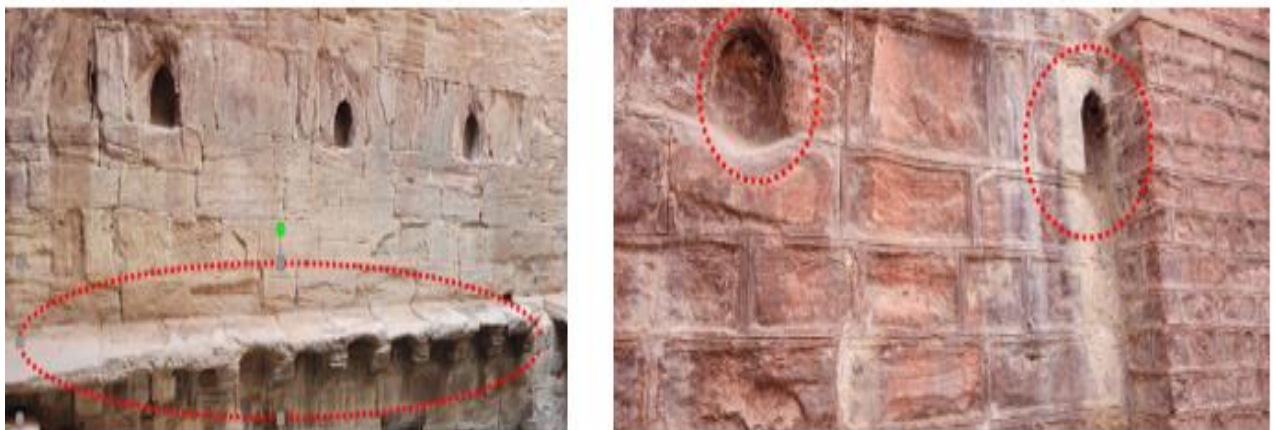
(h) Deformation: - Change in shape without losing integrity, leading to bending, buckling, or twisting of a stone block.

Cases: • Stress

Figure 19: Stress Deformation

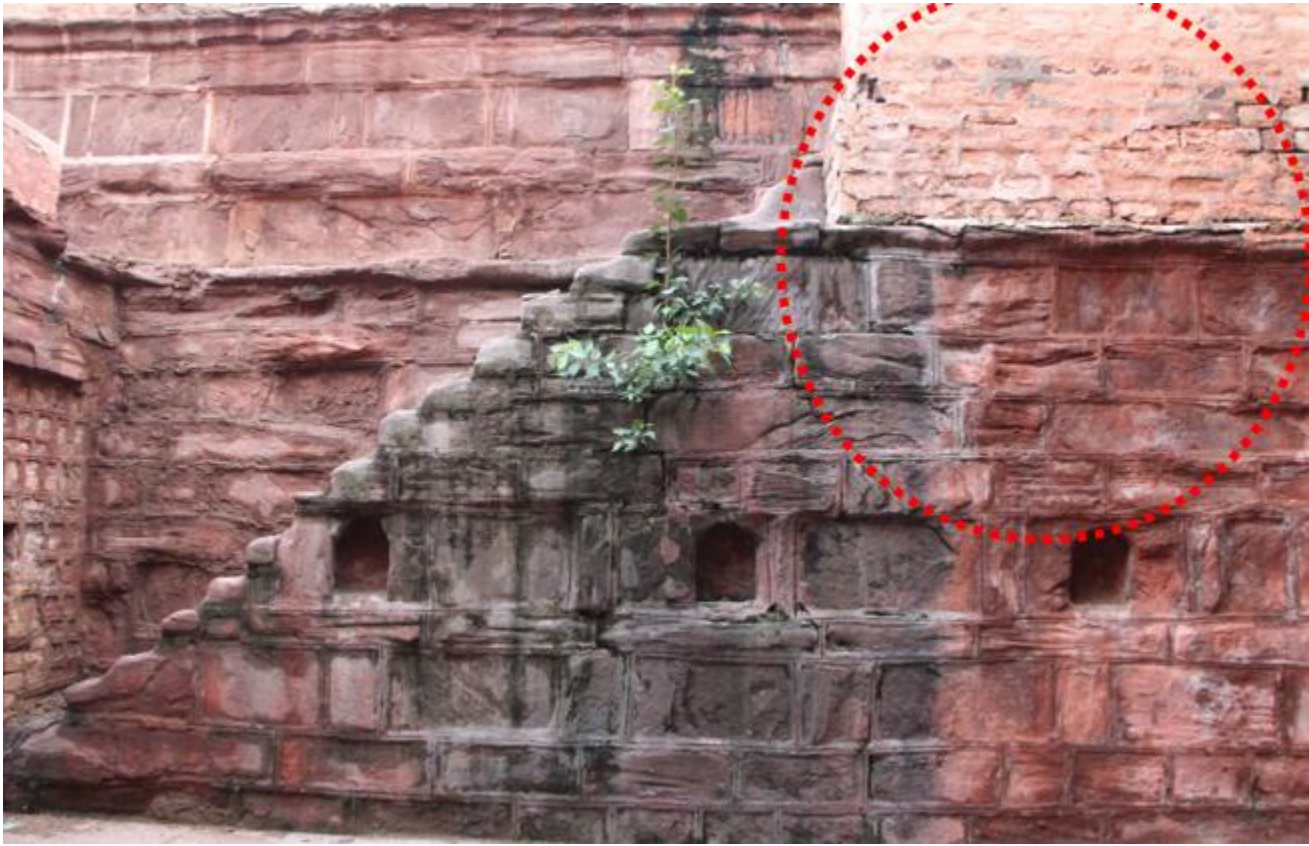
(i) **Discoloration:** - Change the stone colour in one to three of the colour parameters: hue, value and chroma. - hue corresponds to the most prominent characteristic of colour (blue, red, yellow, orange etc.). - value corresponds to the darkness (low hues) or lightness (high hues) of a colour. - chroma corresponds to the purity of a colour. High chroma colours look rich and full. Low chroma colours look dull and greyish. Sometimes chroma is called saturation

- Water run off
- Cracks
- Fractures
- Holes

Figure 110:Discoloration

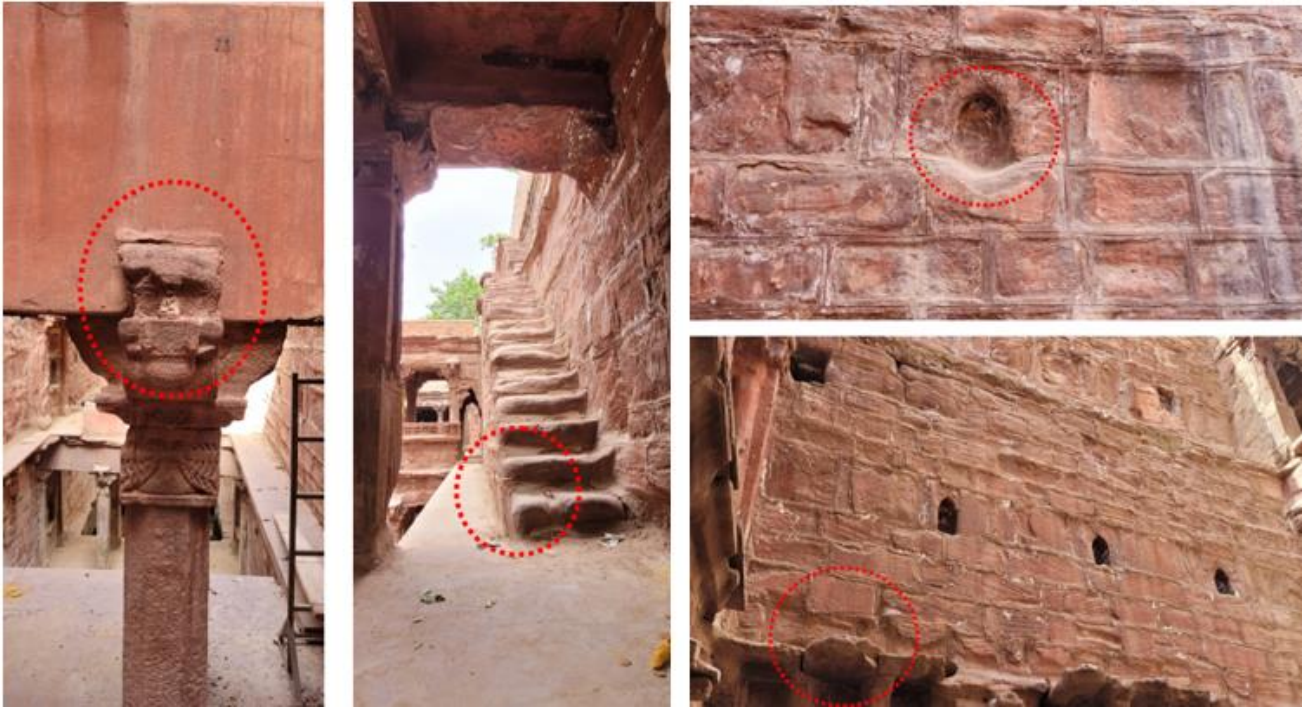
(j) **Erosion and Weathering:** - Loss of original surface, leading to smoothed shapes. Any chemical or mechanical process by which stones exposed to the weather undergo changes in character and deteriorate.

- Excessive vibrations
- Improper floating tool
- Damp
- Mineral released iron oxidation
- High water table

Figure 111: Erosion and Weathering

Figure 112: Erosion and Weathering

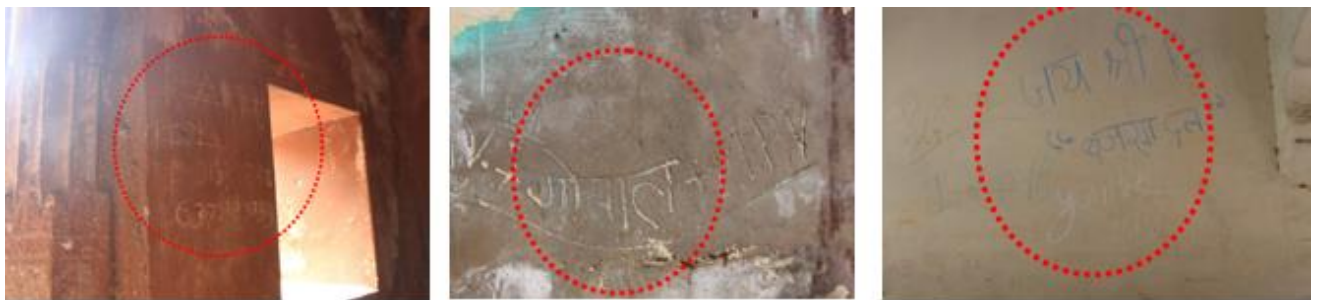
(k) Graffiti: - Engraving, scratching, cutting or application of paint, ink, or similar matter on the stone surface.

- Human Intervention

Figure 113: Inking

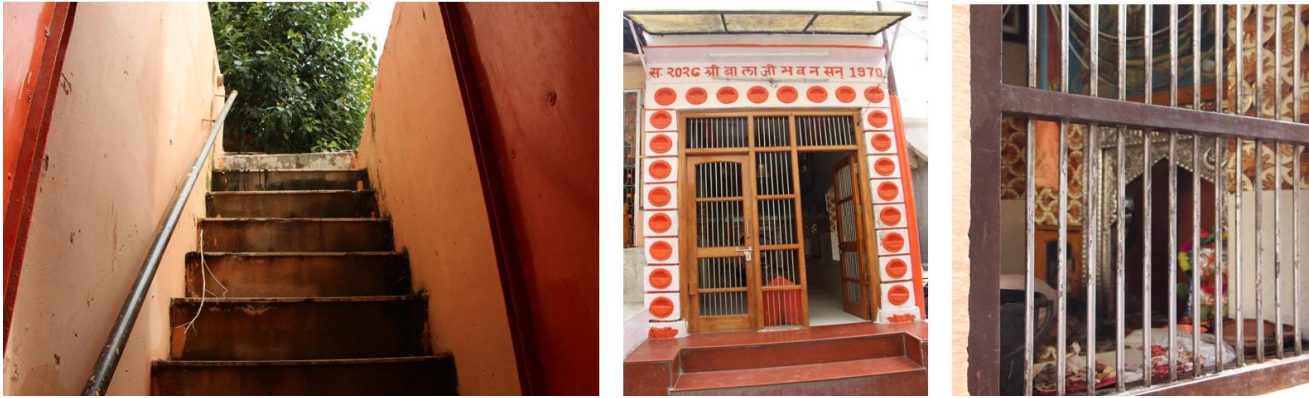
(l) Later, Interventions: - Area in and around the Baodi was subjected to further construction. A temple was constructed in the periphery of the Baodi.

(1) Internal Intervention

Figure 14: Intervention

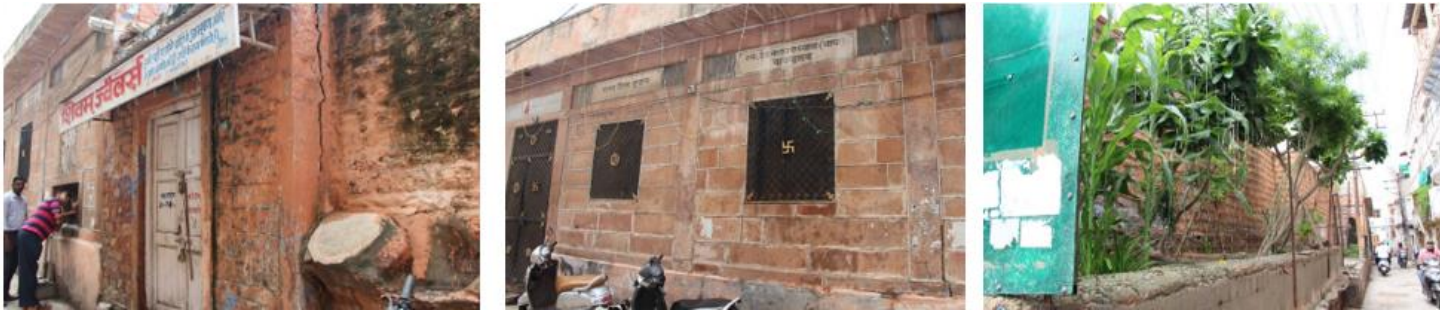
(2) External Intervention

Figure 15: Intervention

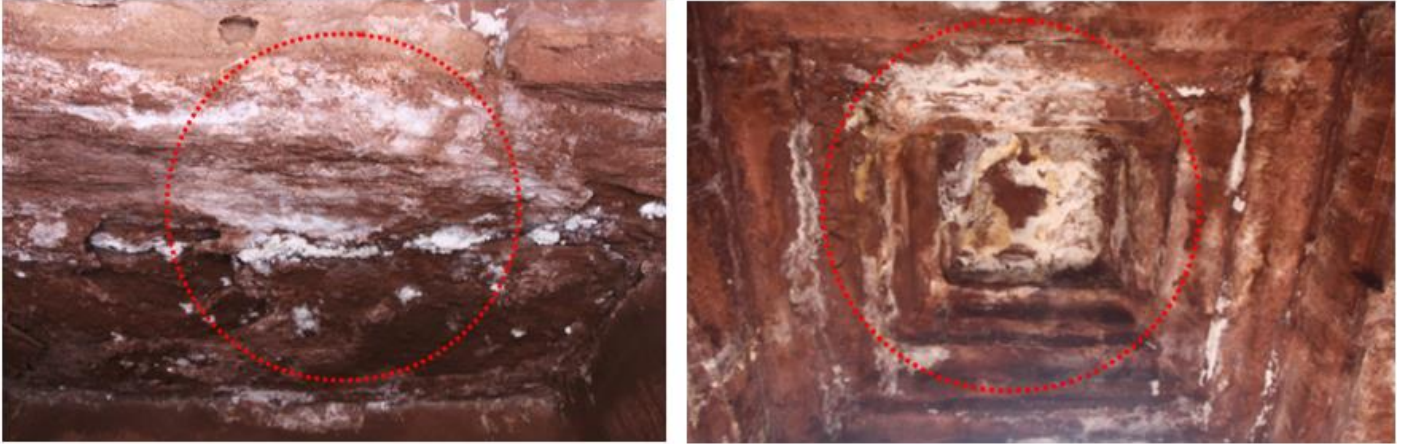
(m) Encrustation and Mikrokrast: - Network of small, interconnected depressions of millimetric to centimetric scale, sometimes looking like a hydrographic network. Mikrokarst patterns are due to a partial and/or selective dissolution of calcareous stone surfaces exposed to water run-off. Deposition of salt compounds on the walls.

Figure 16: Microkarst patterns

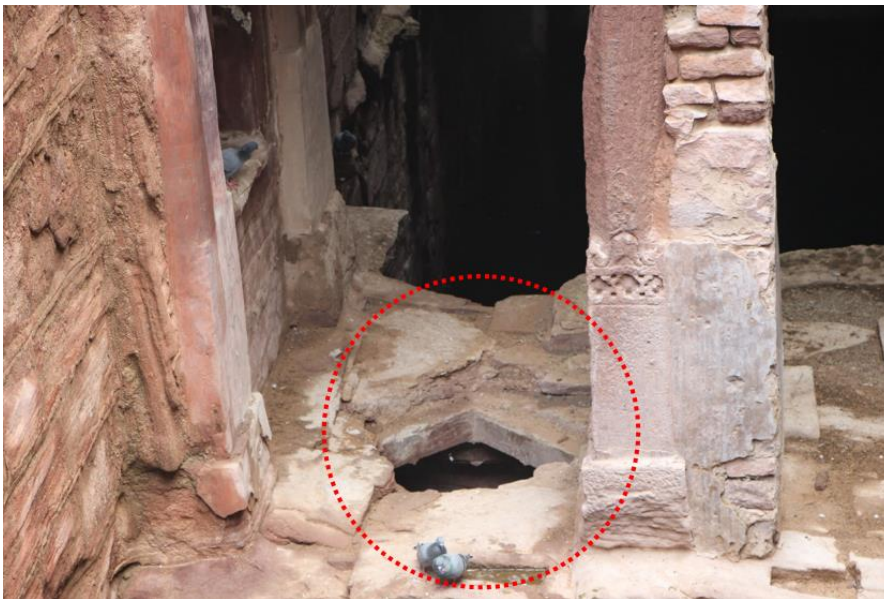
(n) **Mechanical Damage:** - Loss of stone material clearly due to a mechanical action.

- Impact damage
- Key
- Cut
- Scratch
- Abrasion
